**Loss of Pitch Control During Takeoff  
Air Midwest Flight 5481  
Raytheon (Beechcraft) 1900D, N233YV  
Charlotte, North Carolina  
January 8, 2003**

**Aircraft Accident Report**  
**NTSB/AAR-04/01**

**Air Midwest Flight 5481**

**Raytheon (Beechcraft) 1900D, N233YV**

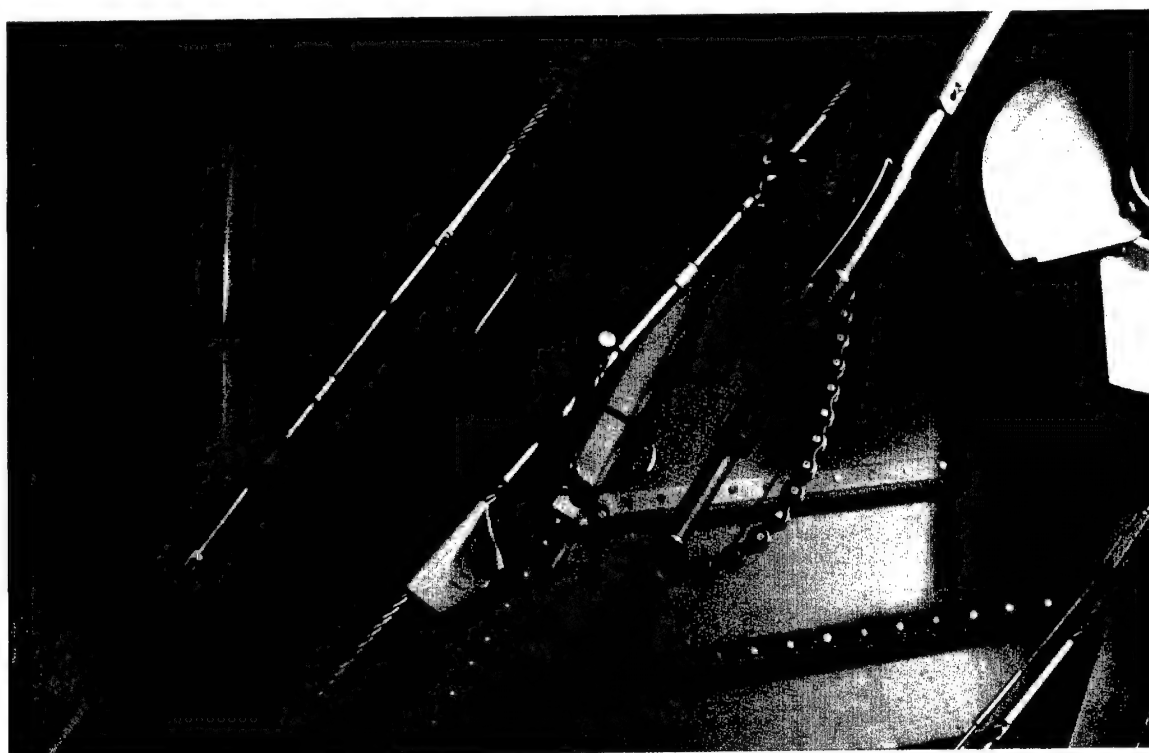
**Figure 5.** Turnbuckle assemblies.

Each turnbuckle assembly can be lengthened or shortened during elevator rigging. Depending on the direction of the turnbuckle barrel's rotation, both threaded cable terminals extend from or contract into the barrel at the same time. A tooling hole in the barrel is used by mechanics to rotate the barrel, and tooling holes in the terminals are used to hold the terminals in place while the turnbuckle barrel rotates. According to FAA Advisory Circular (AC) 43.13-1B, "Acceptable Methods, Techniques, and Practices – Aircraft Inspection and Repair" (dated September 27, 2001), up to three threads of a terminal can be visible on a turnbuckle assembly when maintenance is complete. A safety clip holds the terminals in place in the barrel after maintenance to ensure that the length of the turnbuckle assembly does not change.

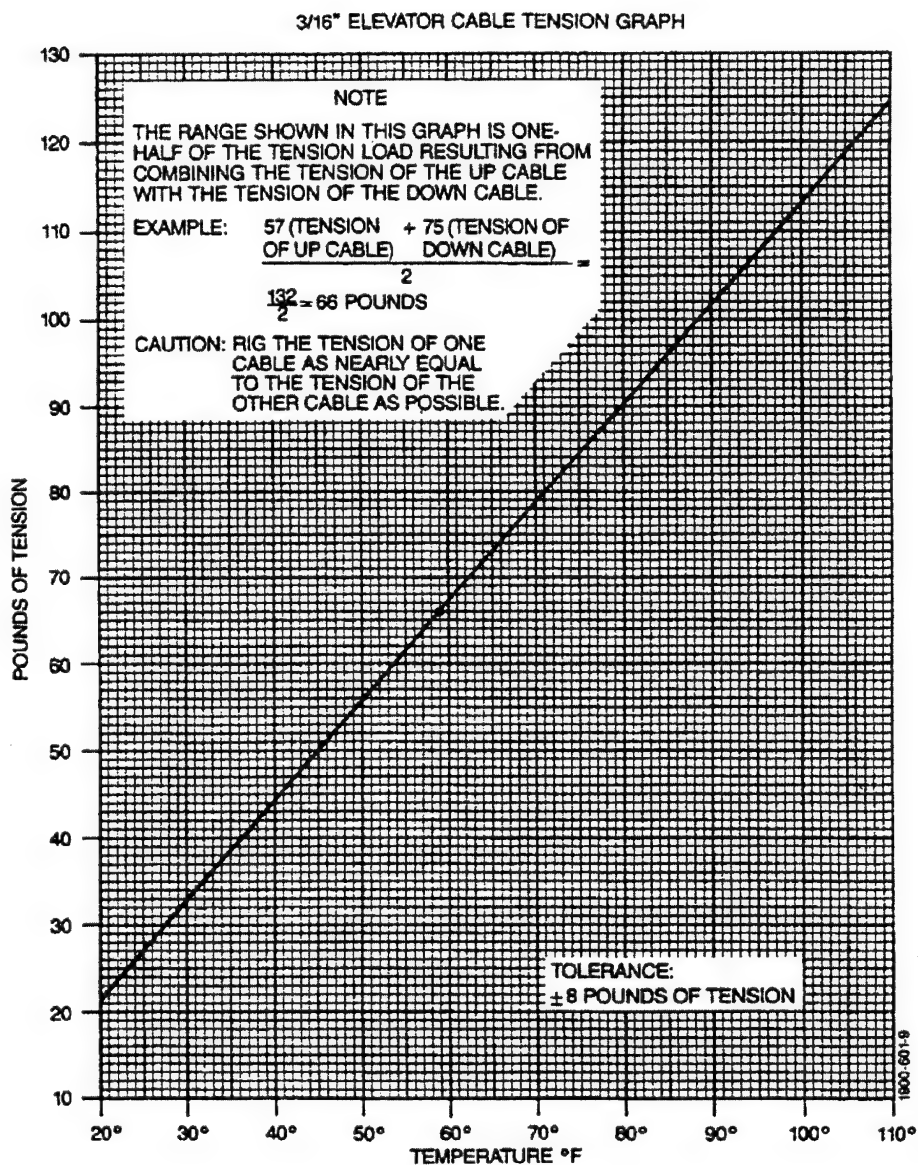
Figure 203 - Elevator Cable Tension Graph

<sup>32</sup> Figure 203 was an elevator cable tension graph included in section 27-30-02 of the Beech 1900D AMM. The graph did not contain instructions on how to take a temperature reading.

- Step q refers the mechanic to the elevator cable tension graph (figure 203) in section 27-30-02 for performing cable tensioning, but no instructions were given regarding whether the airframe, outside air, or cable temperature was to be taken when determining the amount of cable tension; whether the flight compartment cabin temperature gauge or an outside air temperature gauge was to be used in determining the temperature; and what type of device was to be used to measure cable tension.

Regarding the Air Midwest accident, the elevator cable tension graph (figure 203) in the elevator control system rigging procedure did not contain instructions on how to take a temperature reading, which was needed to determine the tension values at which the cables should be set. Regarding the Colgan Air accident, the elevator trim system rigging procedure showed an incorrect illustration of the forward elevator trim cable drum. This error could have resulted in the incorrect installation of the elevator trim cable and elevator tab operation in the direction opposite of that commanded by the trim wheel. Regarding the CommutAir incident, the Beech 1900D AMM did not contain a procedure for replacing a thrust lever detent pin.<sup>152</sup>
